Iron Pot Creek

Drainage and Erosion Management Plan

Client : Ipswich City Council
Prepared by : Australian Wetlands Consulting Pty Ltd and Bligh Tanner
Project # : 1-12185
Date : January 2013

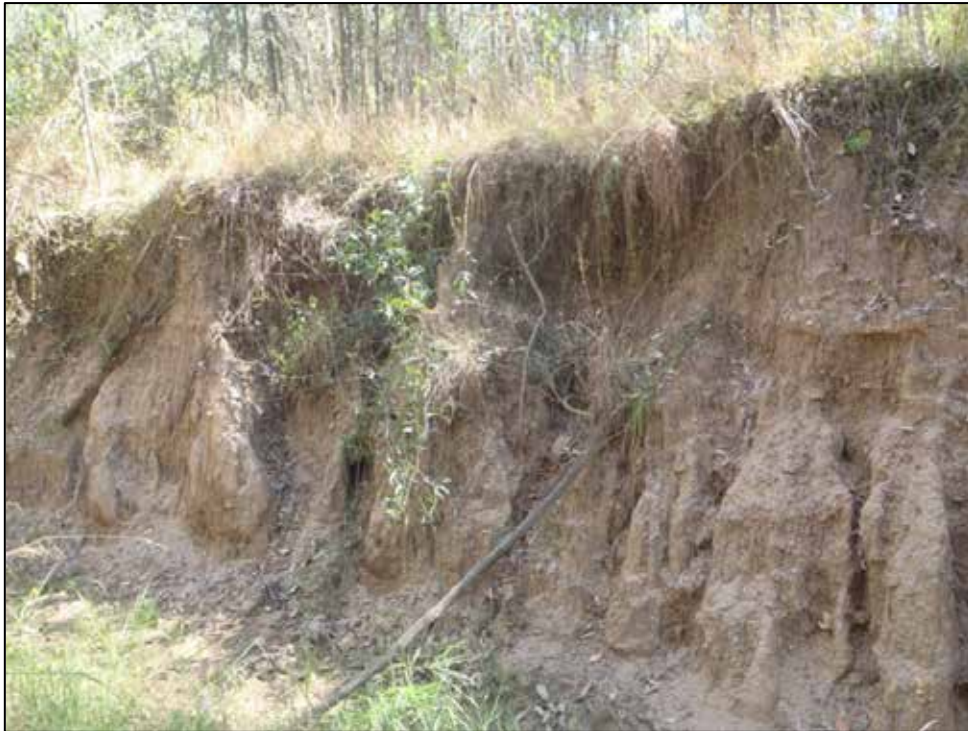
Figure 4-5 Soils typical of Iron Pot Creek

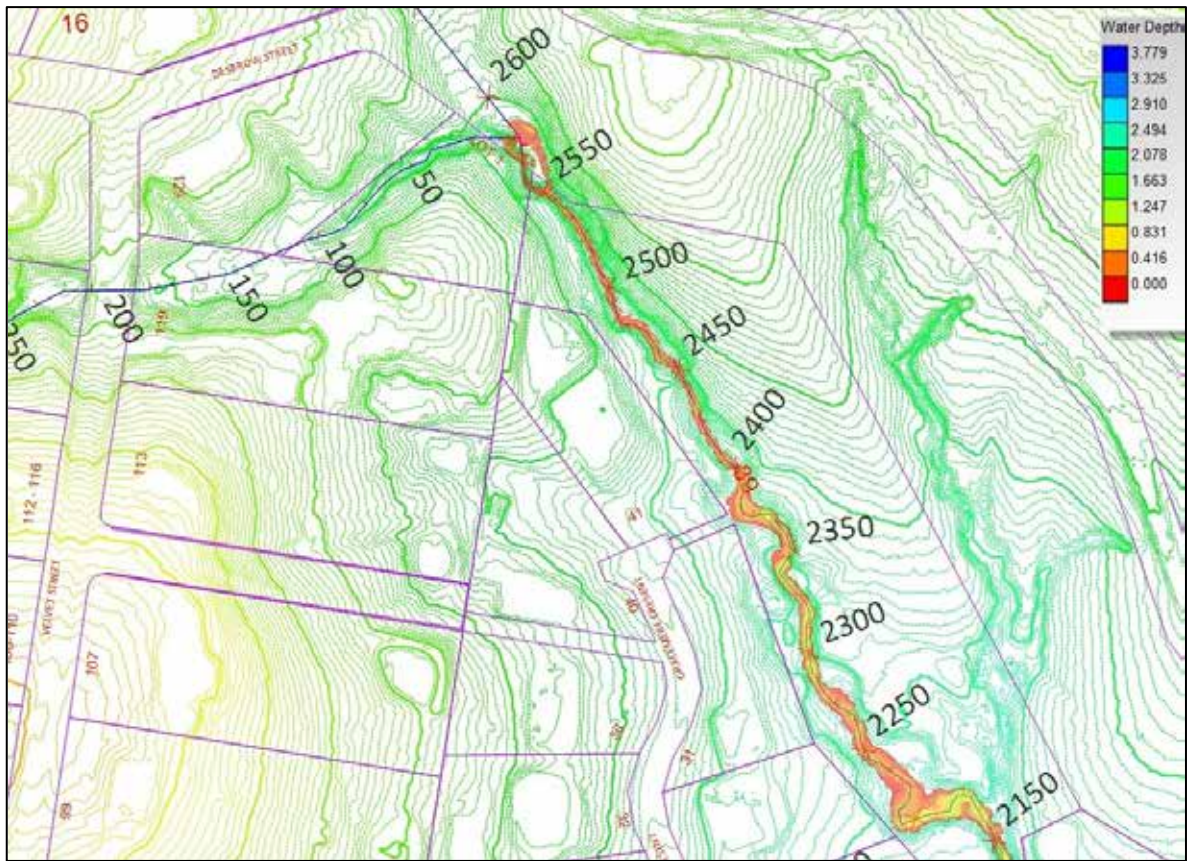
The creek has enlarged significantly, so that large flood events like the 100 yr ARI are almost completely contained within the creekbanks in the upper reaches (for Reaches 1a to 1c, except where there are constrictions like the culvert on Wairuna Ct). Figure 4-6, Figure 4-7, Figure 4-8, Figure 4-9 and Figure 4-10 shows water depths through management zones 1 to 4.

Figure 4-6 Iron Pot Creek Zones 1A and 1B Q100 water depth and extent (uncalibrated)

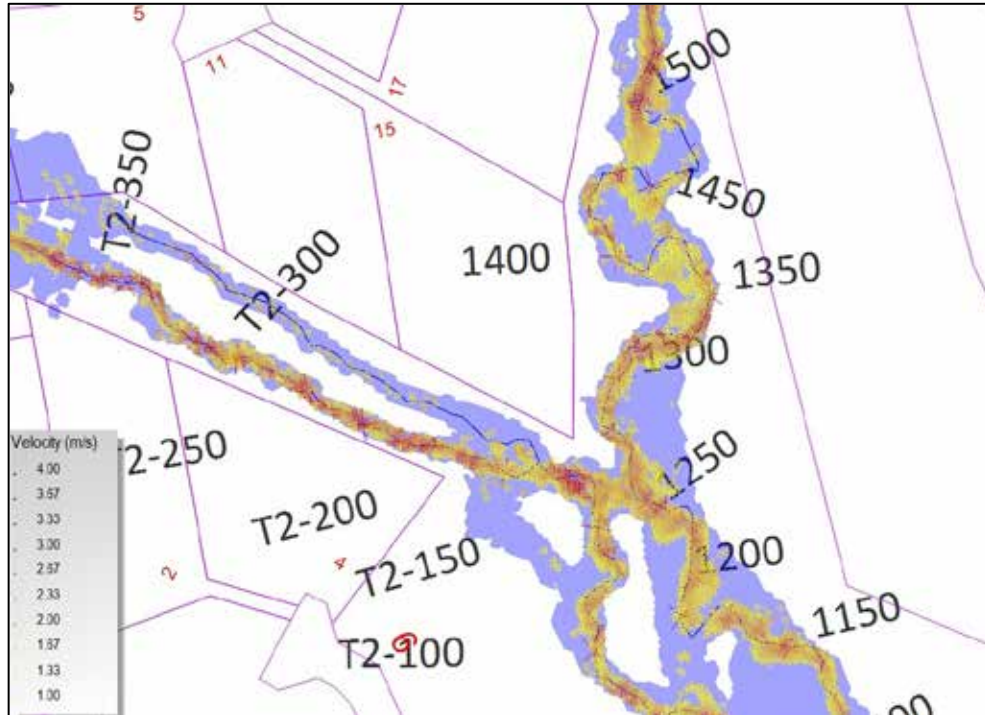
The flows are highly non-uniform and velocities in the channel vary widely depending on the specific location in the cross section. Velocities throughout the creek are highly variable and influenced by localised channel shape and turbulence. Overall, average peak velocities through the creek are roughly doubled compared to natural conditions (for a 2 yr ARI storm) refer Figure 4-11.

Figure 4-11 Iron Pot Creek Zone 2A Q100 peak velocity

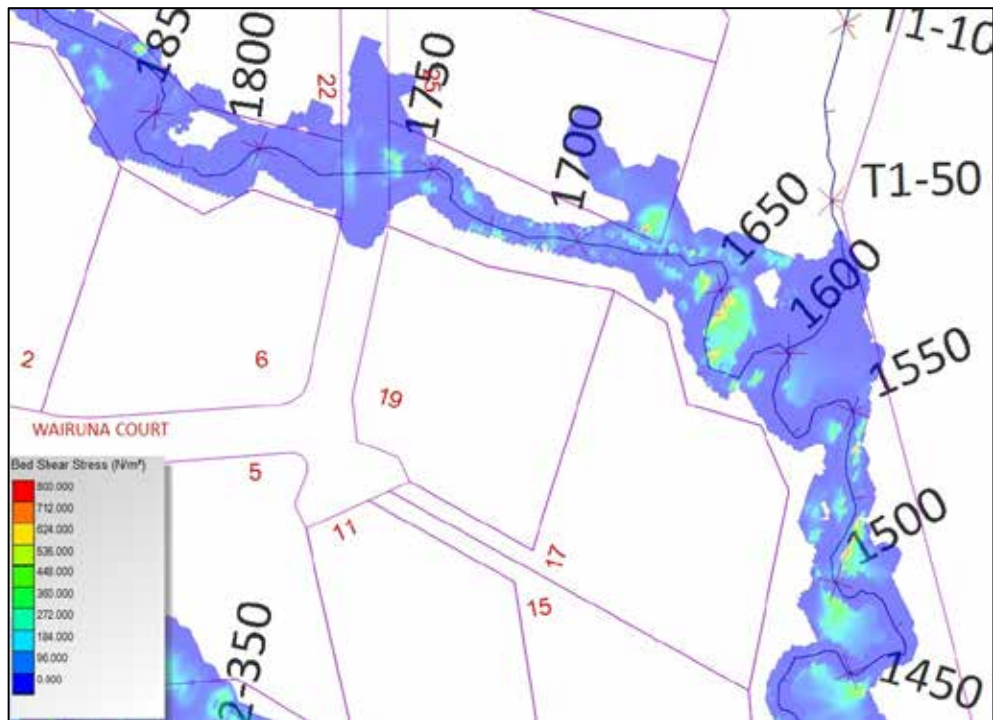
Shear stress is the force exerted by streamflows on the stream bed and bank, and is a more useful indicator of erosion than velocities. The detailed 2D modelling undertaken for this project enables the complex channel geometry to be taken into consideration so that the force of flows on bends and various channel features can be understood. Selected plots of shear stress in the creek are presented in the following figures. As a very crude guide to interpreting shear stress values, the shear stress value in Pa roughly equates to the particle size, in mm, that such a force could erode. For example, a shear stress value of 50 Pa could move a particle 50 mm in diameter. Shear stress results for zones 1C and 2A are provided in Figure 4-12. They show that in many areas shear stress values exceed 100 Pa, and occasionally exceed 500 Pa, meaning rocks up to 500 mm diameter could be mobilised by floodwaters. This is consistent with anecdotal evidence provided by residents who have placed rocks in the creek to try and stem erosion.

Figure 4-12 Zones 1C and 2A shear stress results

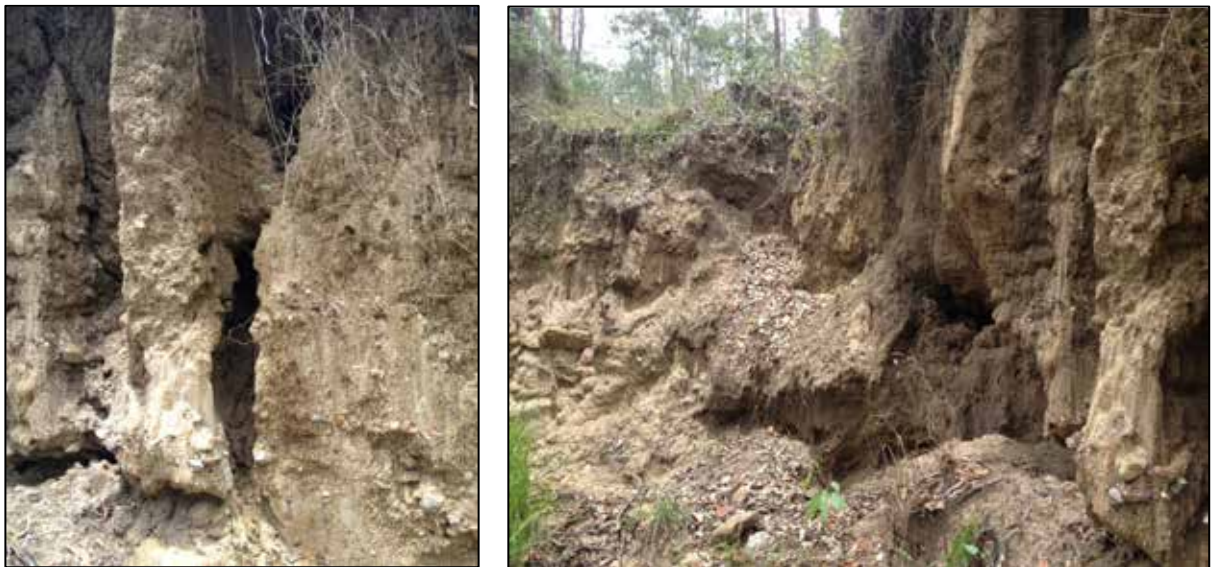
The extent and severity within the catchment requires a comprehensive investigation to determine what the most appropriate management responses might be.

Figure 6-1 Expression of tunnelling on exposed creek banks within Zone 1b

- Gypsum should be re-applied to the affected area every 2-3 years,
- Trafficking and grazing of affected areas should be avoided,
- There are reports of hydrological barriers being effective in intercepting water flowing within tunnels. This involves installation of a sand-gypsum mixture within a trench running through and perpendicular to the tunnel combined with an earth mound immediately upslope to divert surface runoff around the trench. Water within the tunnel is intercepted and expresses at the surface.

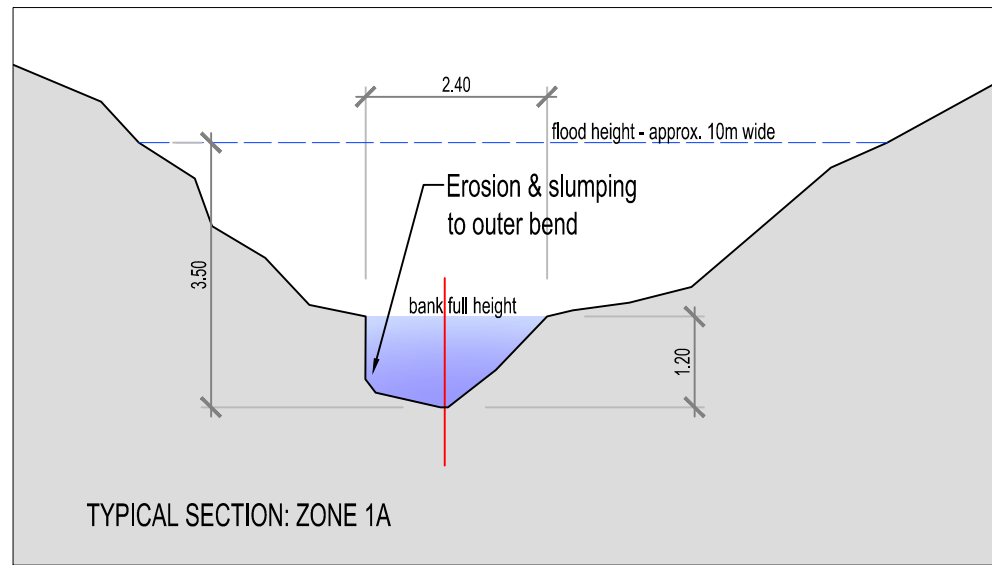
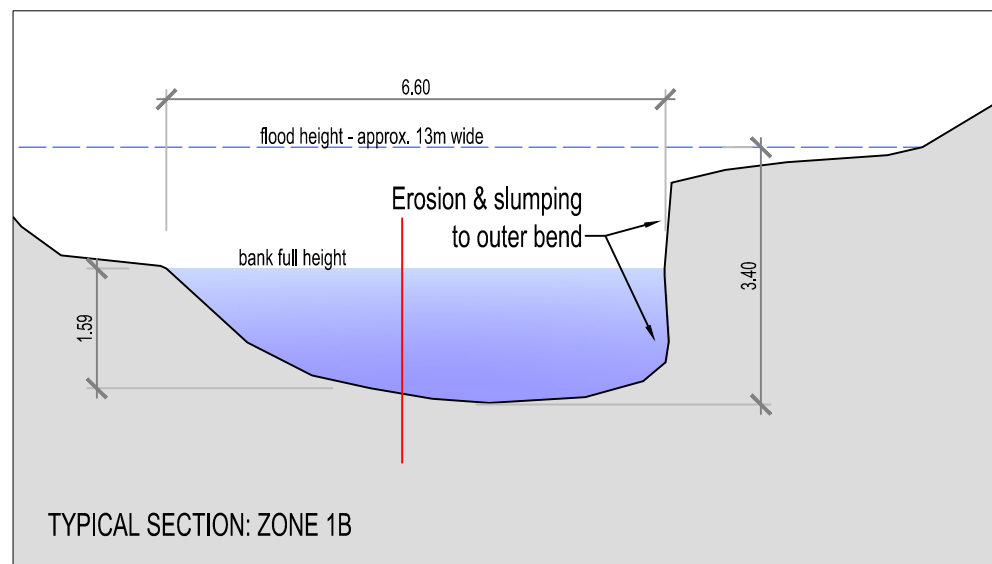
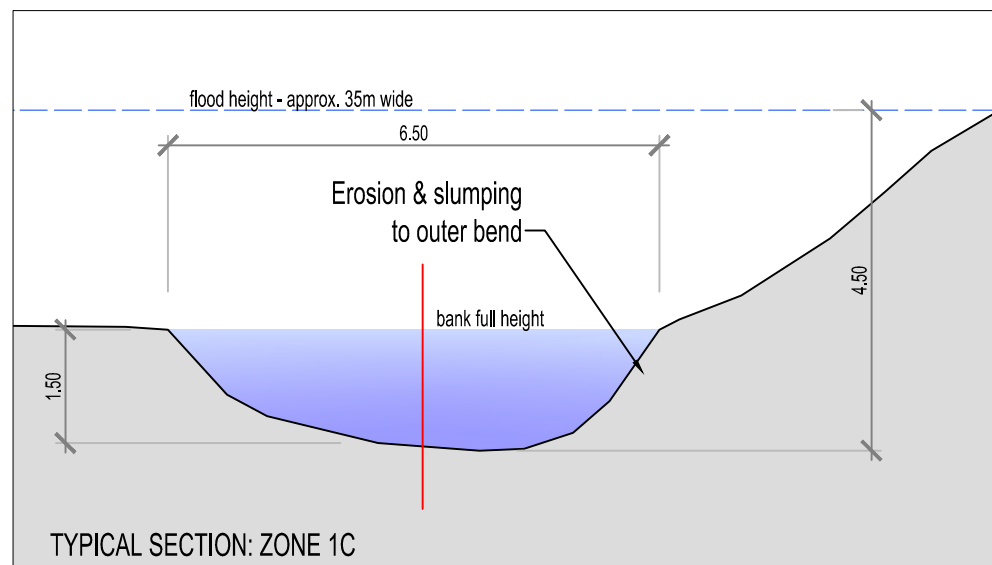
Zone 1a, 1b, 1c, 1d & 1e

Stream types: G4 to G3 (1a, 1b); G4 to F5b (1c)

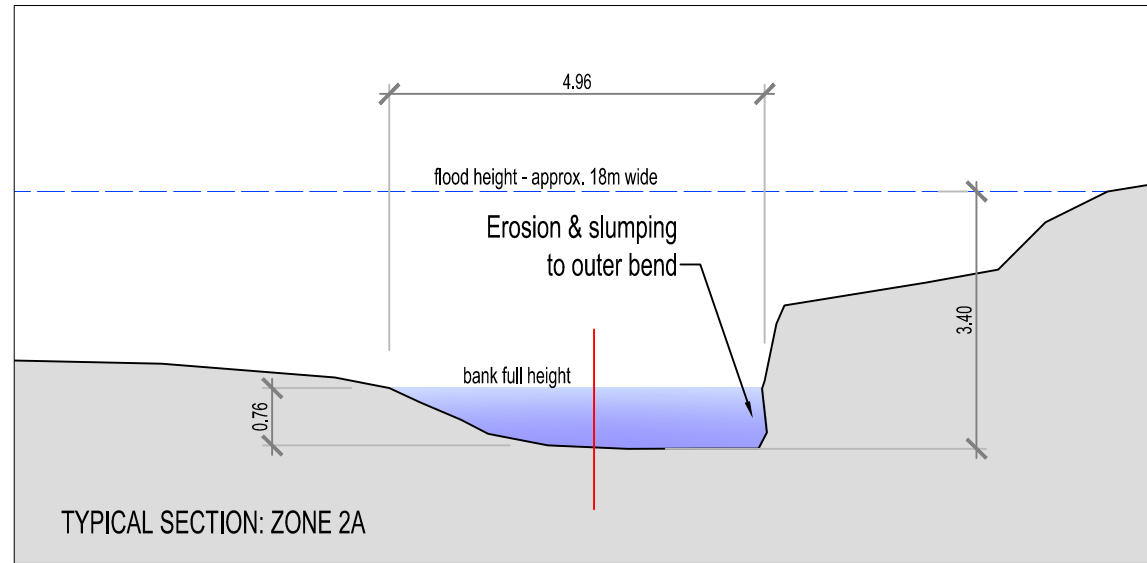
Zones 2a, 2b & 3

Stream types: E5 (2a); G4 to G5 (2b); E5/E5b (3)

| Engage with the community around dumping of garden waste and encroachment within Council reserves | H |
| Implement a weed management strategy | M |
