Iron Pot Creek

Drainage and Erosion Management Plan

Client : Ipswich City Council
Prepared by : Australian Wetlands Consulting Pty Ltd and Bligh Tanner
Project # : 1-12185
Date : January 2013

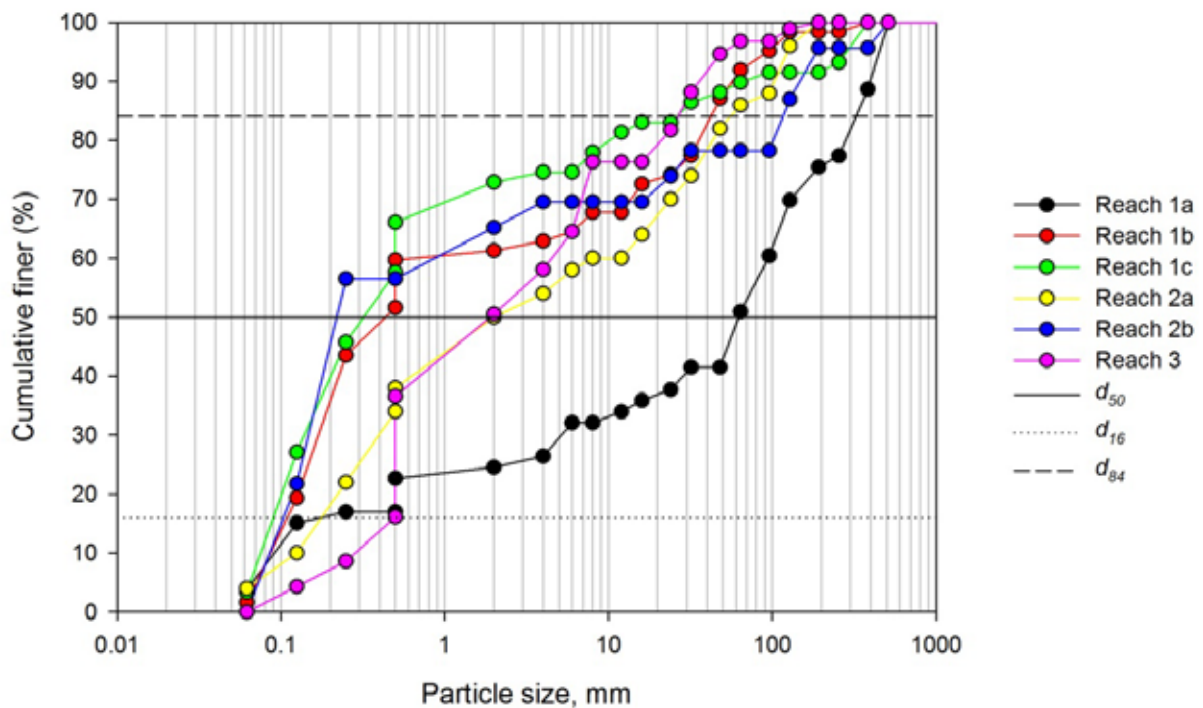
Figure 4-1 Cumulative Sediment Particle Size Results with log normal distribution.

Figure 4-1 shows the cumulative sediment sampling results for all of the Zone's samples and confirms that the coarsest sediment fraction was within Zone 1a and the finest fraction within Zone 1c. The median sample size for the entire study area (d_{50}) ranged from approximately 150 μm through to approximately 90 mm. Sediment histograms for each Zone are displayed within Figures 3.2 – 3.4.

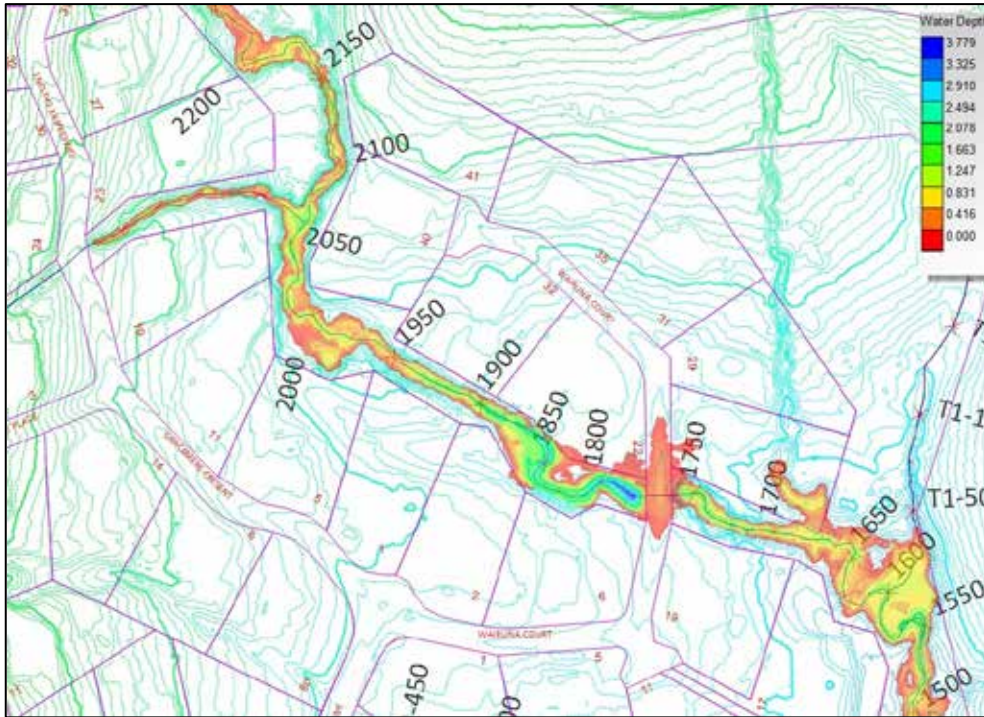
Figure 4-7 Iron Pot Creek Zone 1C Q100 water depth and extent (uncalibrated)

The creek has enlarged significantly, so that large flood events like the 100 yr ARI are almost completely contained within the creekbanks in the upper reaches (for Reaches 1a to 1c, except where there are constrictions like the culvert on Wairuna Ct). Figure 4-6, Figure 4-7, Figure 4-8, Figure 4-9 and Figure 4-10 shows water depths through management zones 1 to 4.

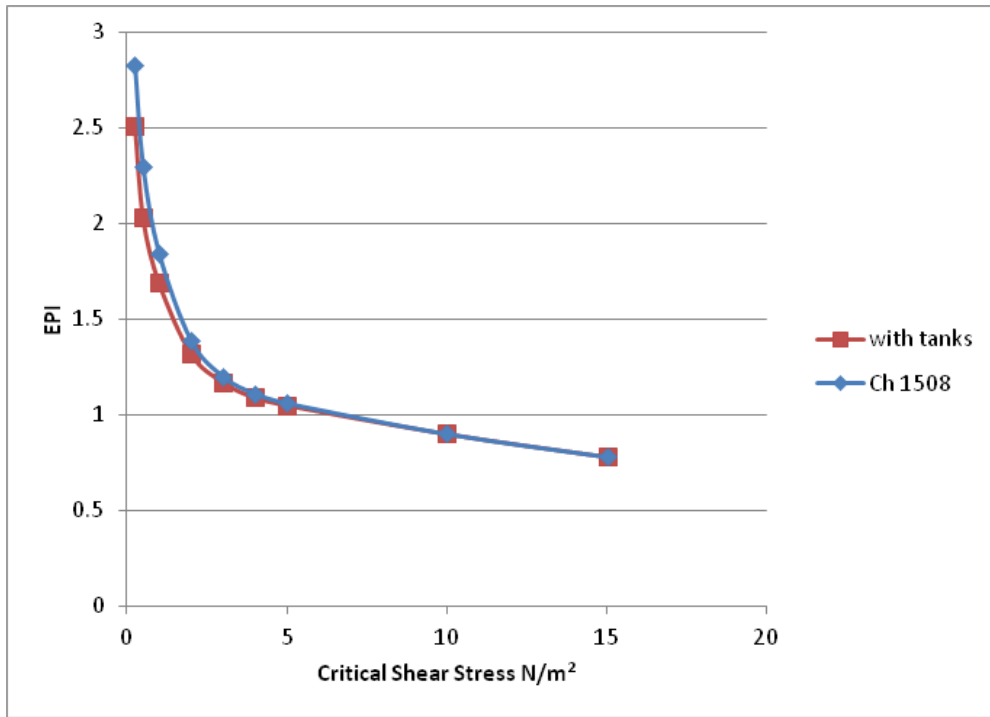
The erosion potential index (EPI) was determined using the methodology outlined in *Water by Design* (2007). This method evaluates the extent to which shear stress—above the critical shear stress the bed material in the channel—has increased compared to natural conditions. The higher the EPI value, the greater the increase in erosion potential compared to natural conditions. Simplified methods like this are not well suited to Iron Pot creek because the bed material is highly variable and doesn't have a single critical shear stress (due to the range of particle sizes and the presence of cohesive and non-cohesive material) and because the shear stress exerted by stream flows are highly variable within and between cross sections. Nonetheless, the method was used to help provide an indication of how effective some catchment interventions might be in reducing the amount of flow. The results in Figure 4-13 below show how the EPI might change if all dwellings installed 20 kL rainwater tanks connected to 75% of their roof areas, and assuming the tanks were configured to ensure the top 1 m of the tank was reserved for flood detention purposes. The results show there would be very little benefit from such an approach, and this is probably because roads and other ground-level impervious surfaces have a large impact on hydrology which is difficult to mitigate in a retrofit situation by addressing roof areas alone.

Figure 4-13 Widespread adoption of large rainwater tanks would have a very minor impact on the erosion potential index.

Detention and retention of runoff would be highly beneficial (it could mean less instream works were required because it would address one of the key causes of erosion), however it is difficult to retrofit enough detention or retention into the catchment, especially given the relatively steep slopes.

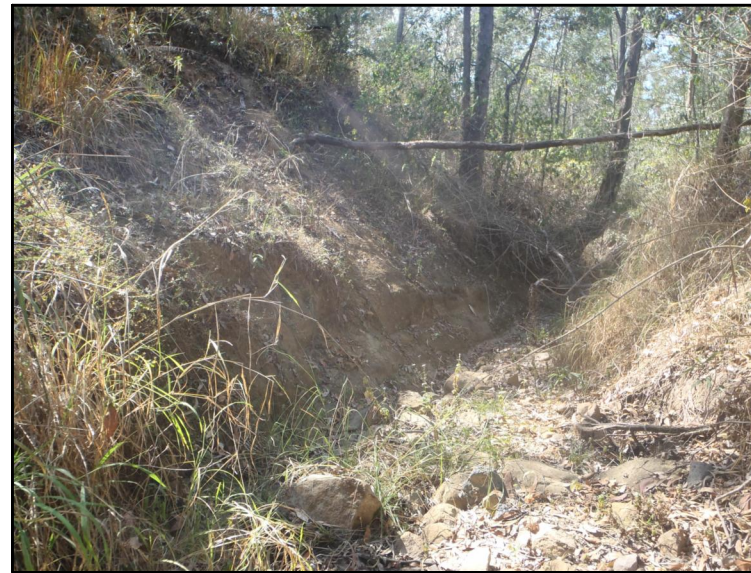
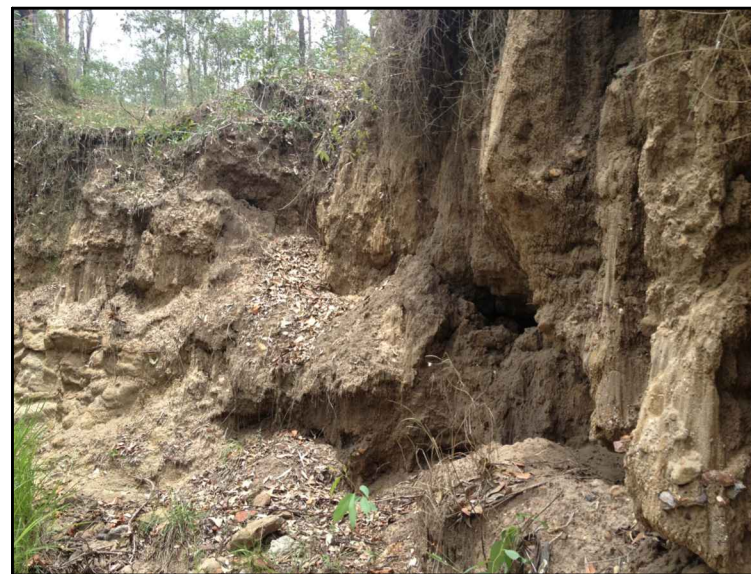
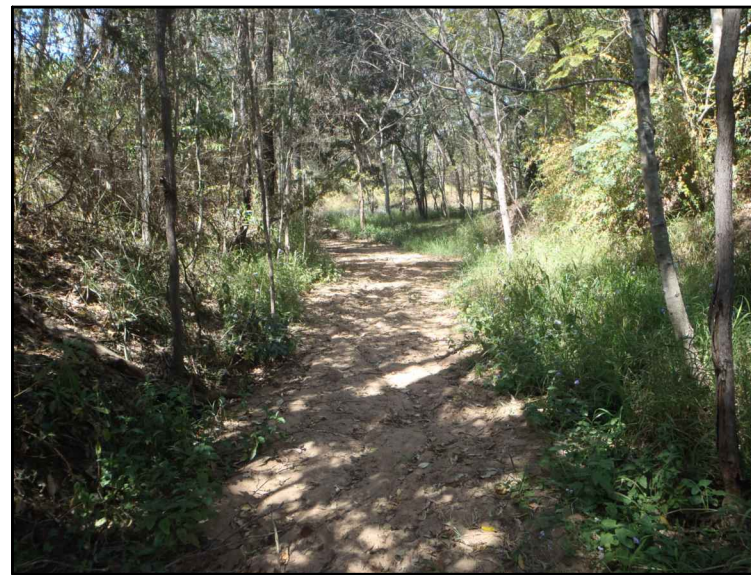
DRAWING	MANAGEMENT ZONES ZONE 1: TYPICAL SECTIONS SITE ANALYSIS & SUMMARY ACTIONS
DRAWING CREATED	9/10/2012

Zone 1a, 1b, 1c, 1d & 1e

Stream types: G4 to G3 (1a, 1b); G4 to F5b (1c)

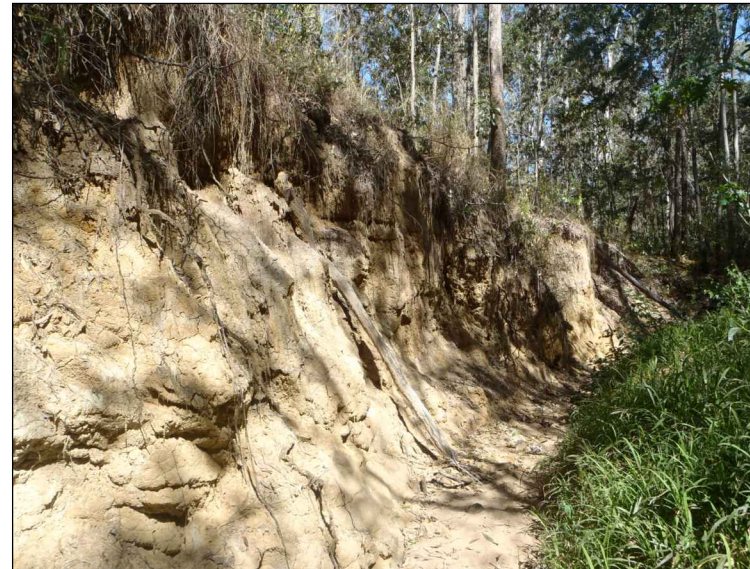
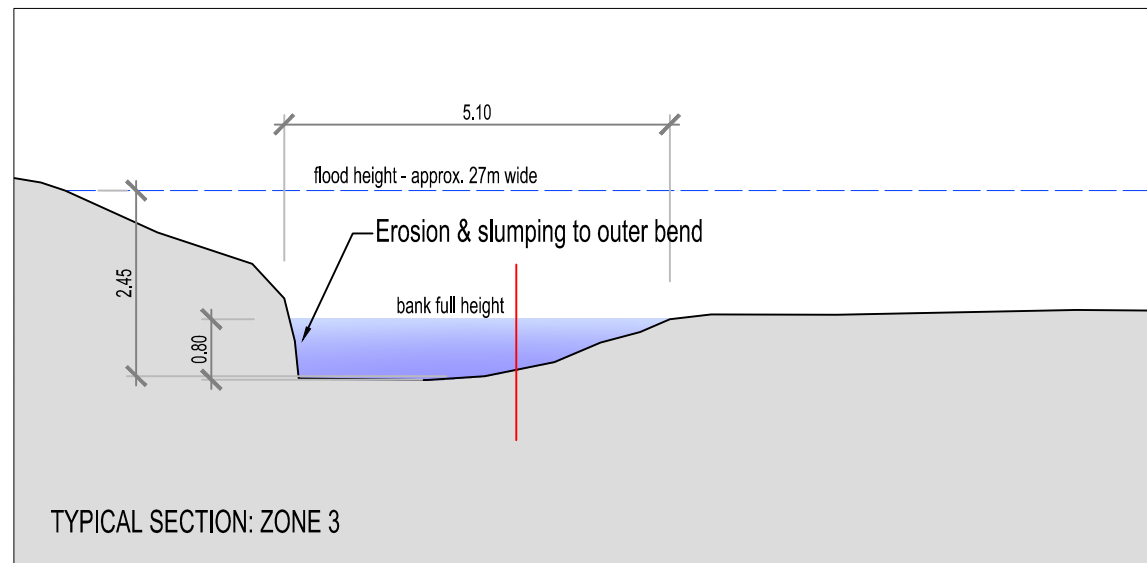
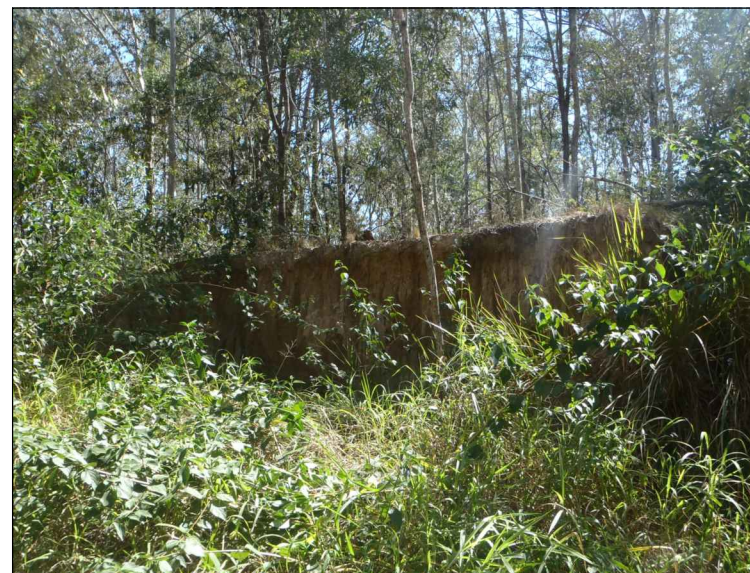
Zones 2a, 2b & 3

Stream types: E5 (2a); G4 to G5 (2b); E5/E5b (3)

| Engage with the community around dumping of garden waste and encroachment within Council reserves | H |
| Implement a weed management strategy | M |

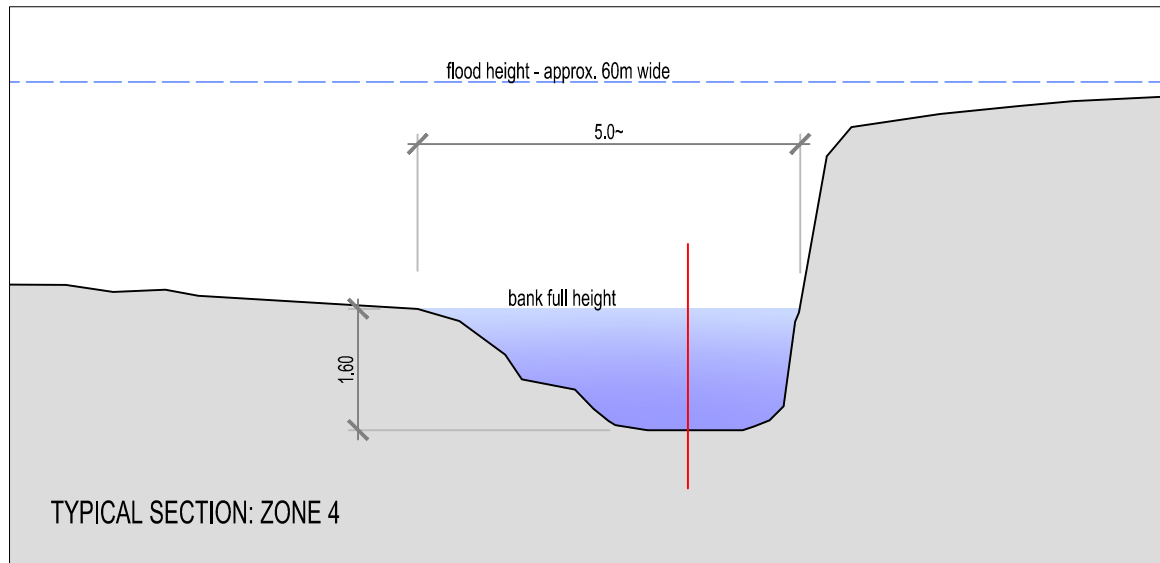
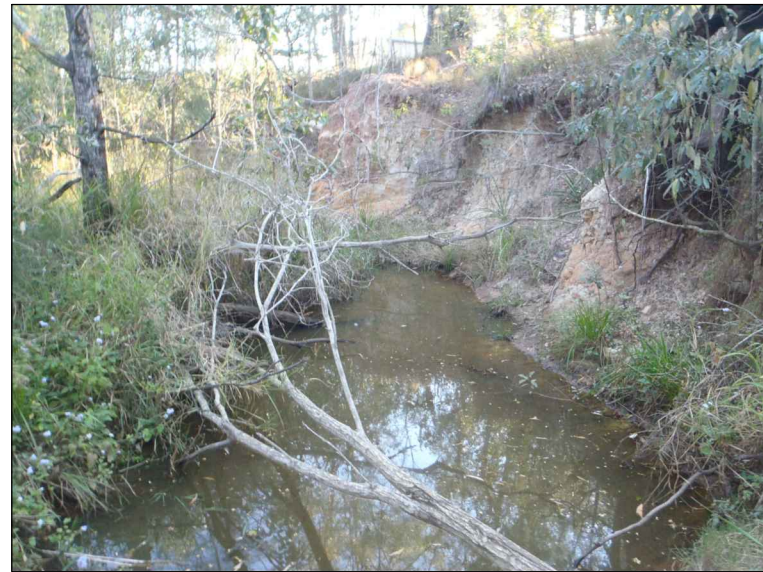
Management Zones 4, 5a, 5b

Stream types: E4 to E5 (4); D5b (5a); G5 (5b)

Zone 4 comprises a broad meandering stream with a well-defined low flow channel and intermittent pools. The zone is generally in excellent condition apart from isolated bank scour and intermittent weeds notably Lantana. Ironpot Creek discharges into Zone 5a via box culverts under Bayley Road and then spreads into a broad flood plain with a mosaic of low flow channels. There are no scour or erosion issues in this zone. On approach to the Warrego Highway a creek channel forms again where there is a head cut developing as well bed lowering and unstable banks.

Implement a weed management strategy

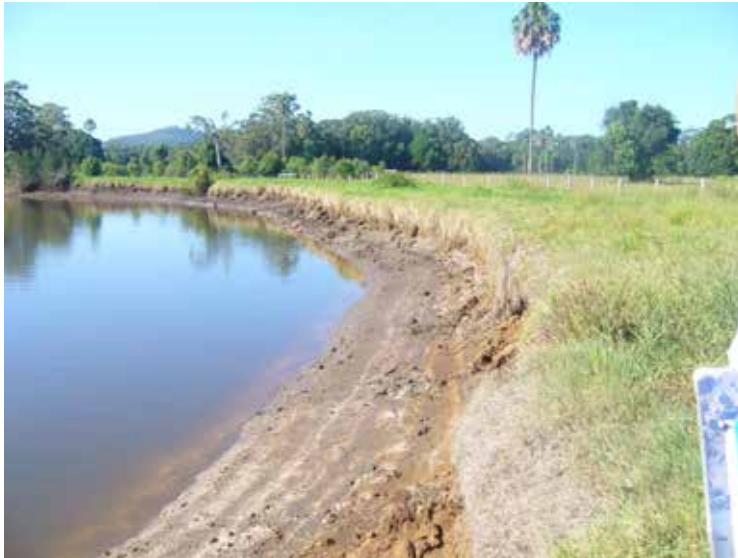
Brunswick River, Mullumbimby: Pre-restoration works 9-2-09
Extreme erosion, scouring, slumping, bank loss

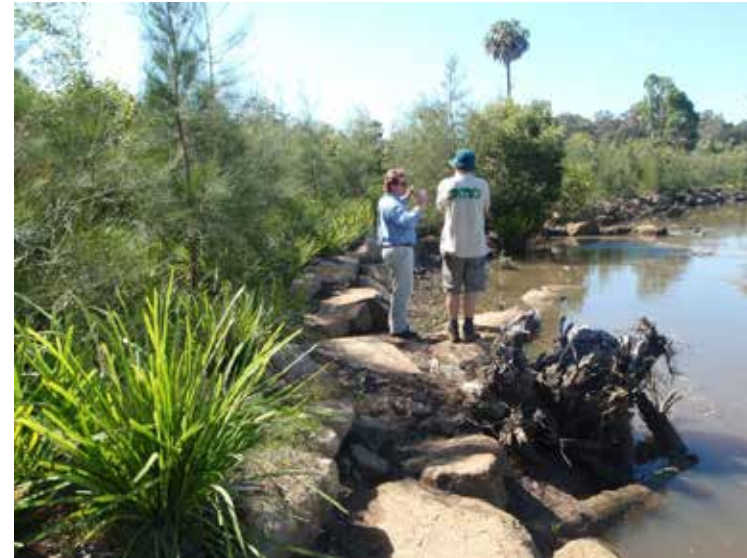
Post restoration works 27-10-10: Bank toe reinforced with LWD & rock scallops. Mangroves & reveg establishing behind structure.

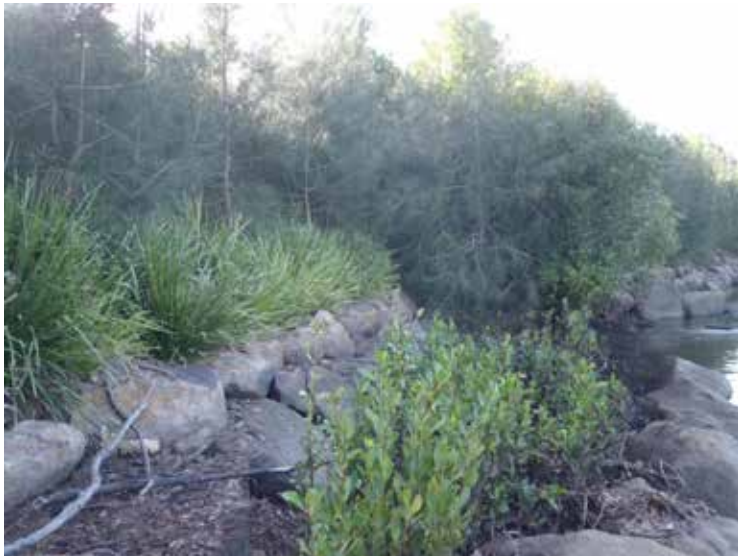
12-1-12: LWD & rock structure stabilised bank, plants established

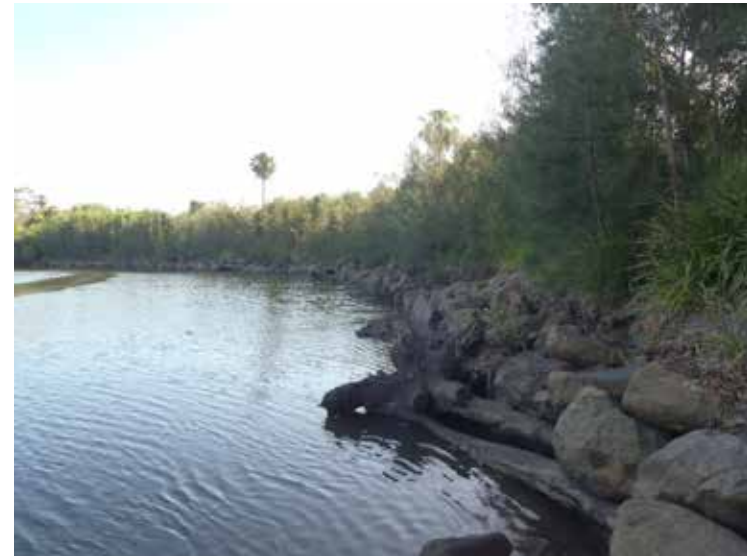
12-1-12: bank erosion halted. Riparian reveg established

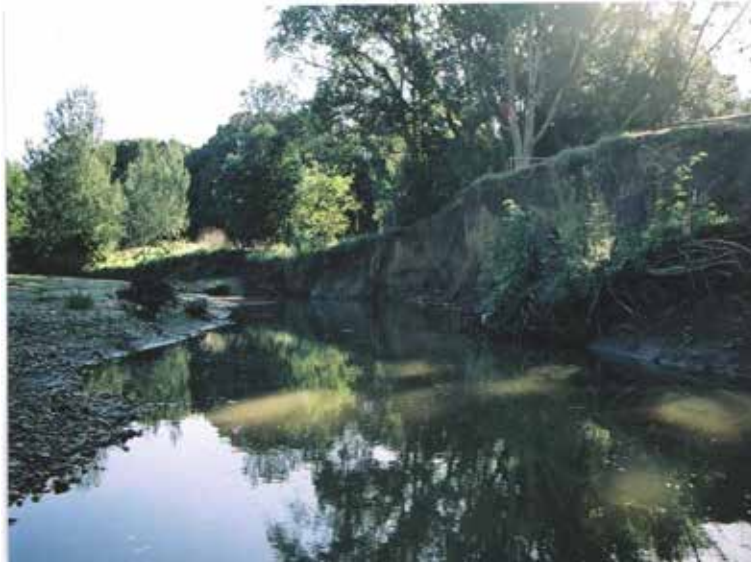
Currumbin Creek: Pre-restoration
Extreme erosion, scouring, slumping, bank loss

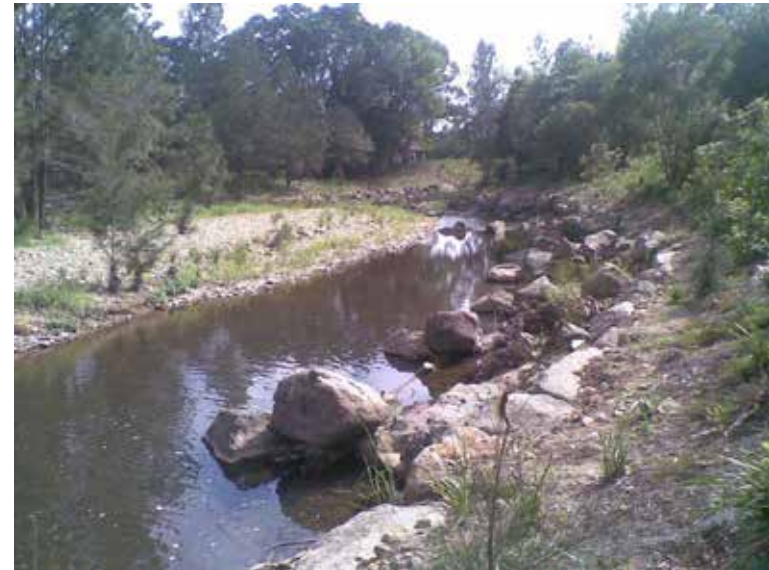
Currumbin Creek: Post restoration works Bank toe reinforced with LWD & rock scallops. Reveg establishing behind structure.
